## GEOPHYSICAL INVESTIGATIONS FOR DELINEATION OF DISTRESSED ZONES AT KALWANDE DAM, MAHARASHTRA

### STUDY OVERVIEW

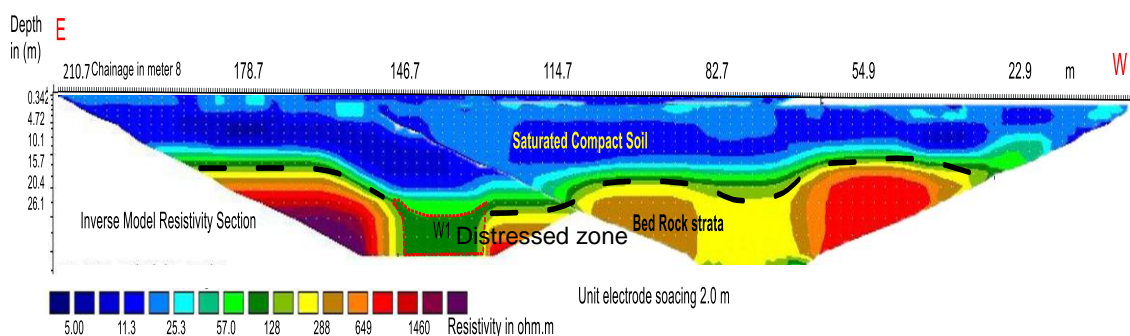
Four ERI profile results represents very low resistivity of  $< 60 \Omega\text{-m}$  indicates highly saturated soils which are susceptible for seepage through dam body. A moderate resistive layer (60 to  $250 \Omega\text{-m}$ ) of varying thickness was observed though out the profile indicates the presence of Weathered/fractured basalt saturated (distressed zone) in the foundation rock. Layer with resistivity  $> 250 \Omega\text{-m}$  was considered as hard compact basalt/ bed rock

ERI studies on the dam axis and the berm, the result signifies the very low resistivity values of  $< 60 \Omega\text{-m}$  were very prominent in the dam body. Moreover, the foundation strata observed below the dam body is highly weathered/fractured basalt which is also more prone to seepage. Low resistivity zones observed in the dam body should be verified by borehole logging if required and should be treated with suitable grout material. On the other hand, the foundation strata is also needs to be treated with suitable grout material as it is observed to be highly weathered/fractured by ERI study and validated with borehole litho logs.

The study results will give the information on distressed zones which are prone to seepage through dam body. Based on the study results project authority can take the remedial measures with suitable grout material to arrest the seepage. The dam authority can serve the purpose of dam by providing water for drinking and irrigation needs.
