**GOVERNMENT OF INDIA
MINISTRY OF JAL SHAKTI
DEPARTMENT OF WATER RESOURCES, RIVER DEVELOPMENT AND
GANGA REJUVENATION**

**TECHNICAL MEMORANDUM
ON
QUALITATIVE ASSESSMENT OF CIVIL STRUCTURES**

September 2025

**CENTRAL WATER & POWER RESEARCH STATION
KHADAKWASLA, PUNE - 411024**

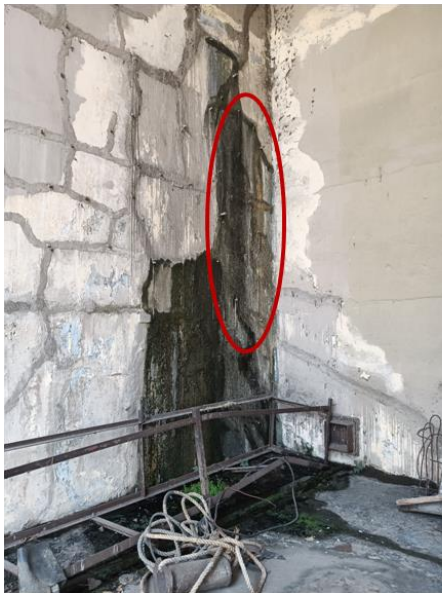
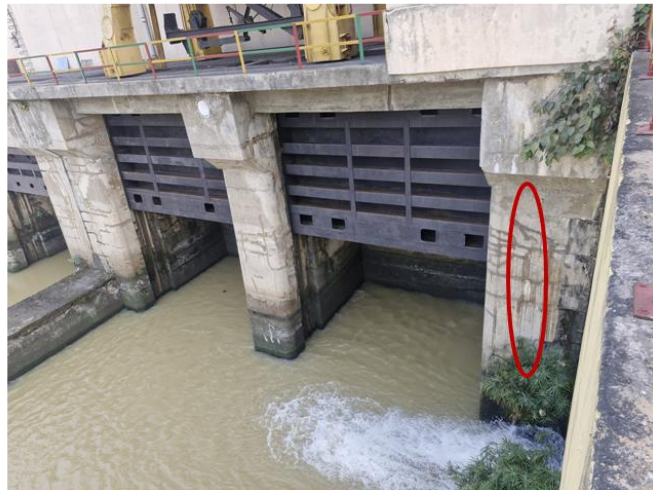
Damages in Wall, Piers, Breast and Divide Walls of Rihand Dam, UP

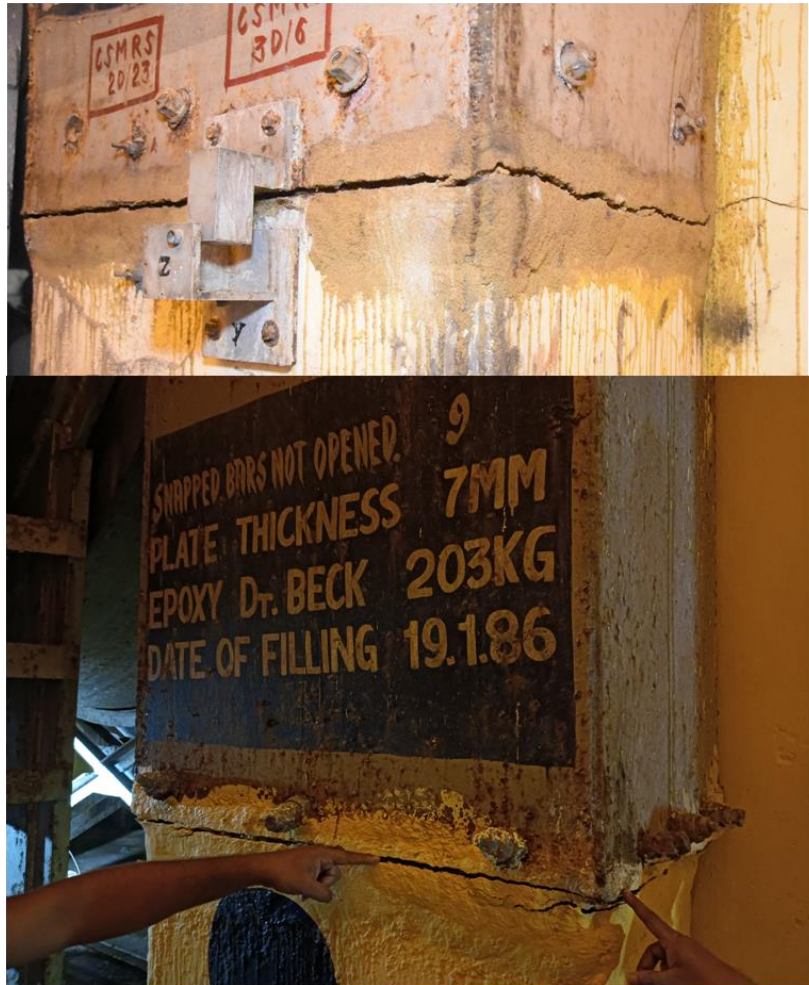
Cracks Observed in the Penstock Gallery Columns

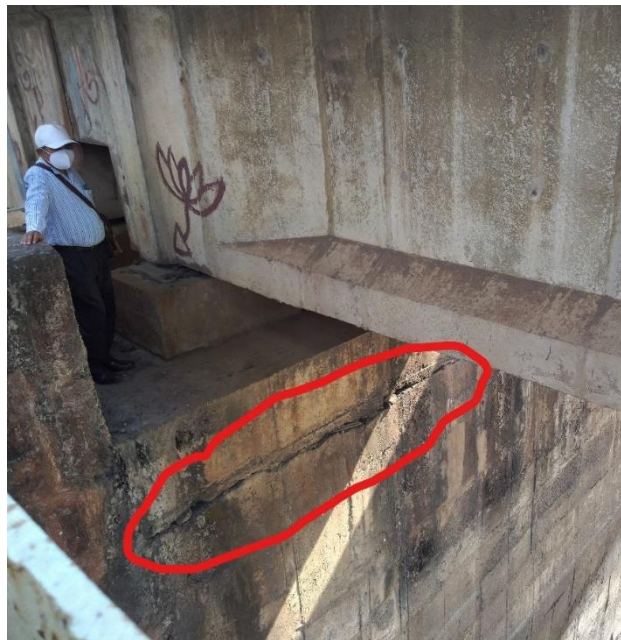
Cracks Observed in Pier

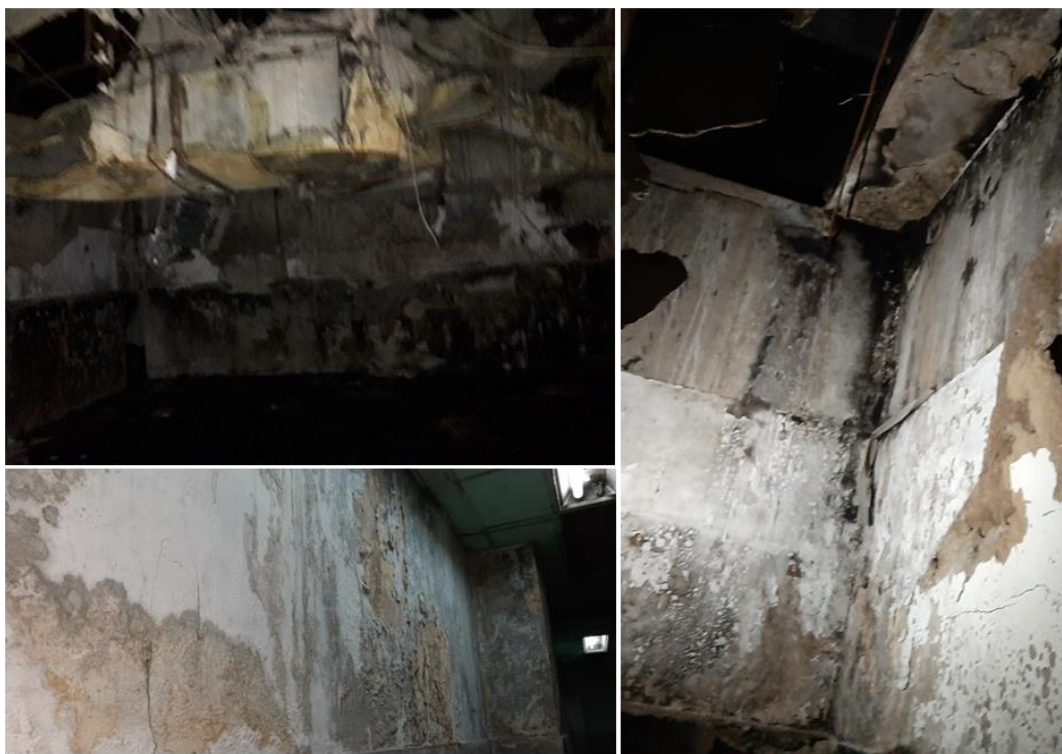
Dampness and Seepage Observed in the Renagli Power House, Odisha

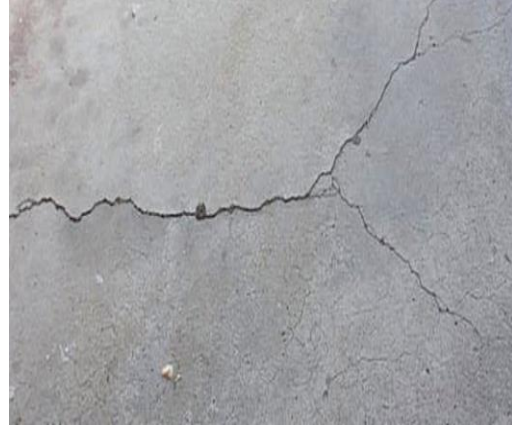
Appearance of Surface Cracks in Concrete

Classification of the degree of damage or condition requires experience and engineering Judgment. Typical defects which are seen in the concrete structures are shown below.

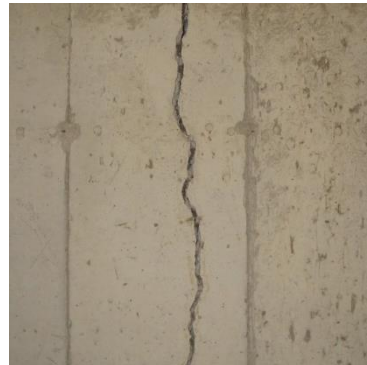
Appearance of Cracks in Concrete due to Settlement

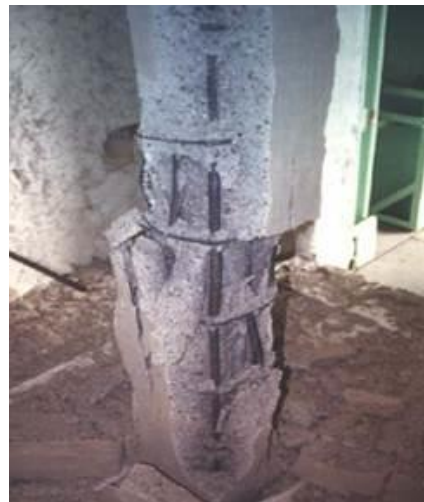
Fire effects on Concrete column

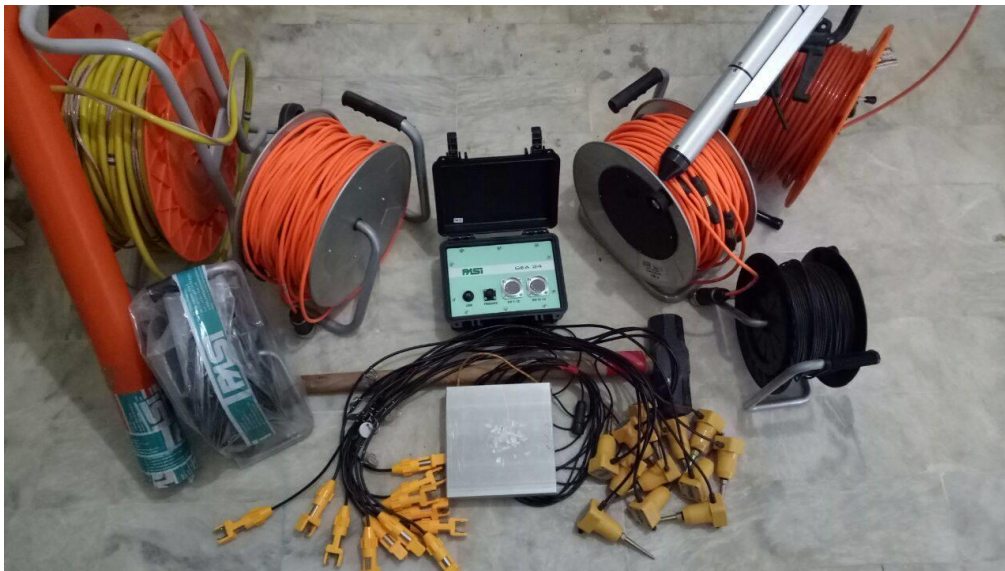
Sonic waves are generated by mild impact of a hammer on the surface of the structure. By generating elastic waves and detecting the arrival of compressional wave, velocities after travelling through the material are evaluated. Quality of concrete is assessed based on the velocity criteria mentioned in IS-516(Part 5/Sec 1):2018.

Sonic wave transmission and refraction survey set up (M/s PASI, Italy)

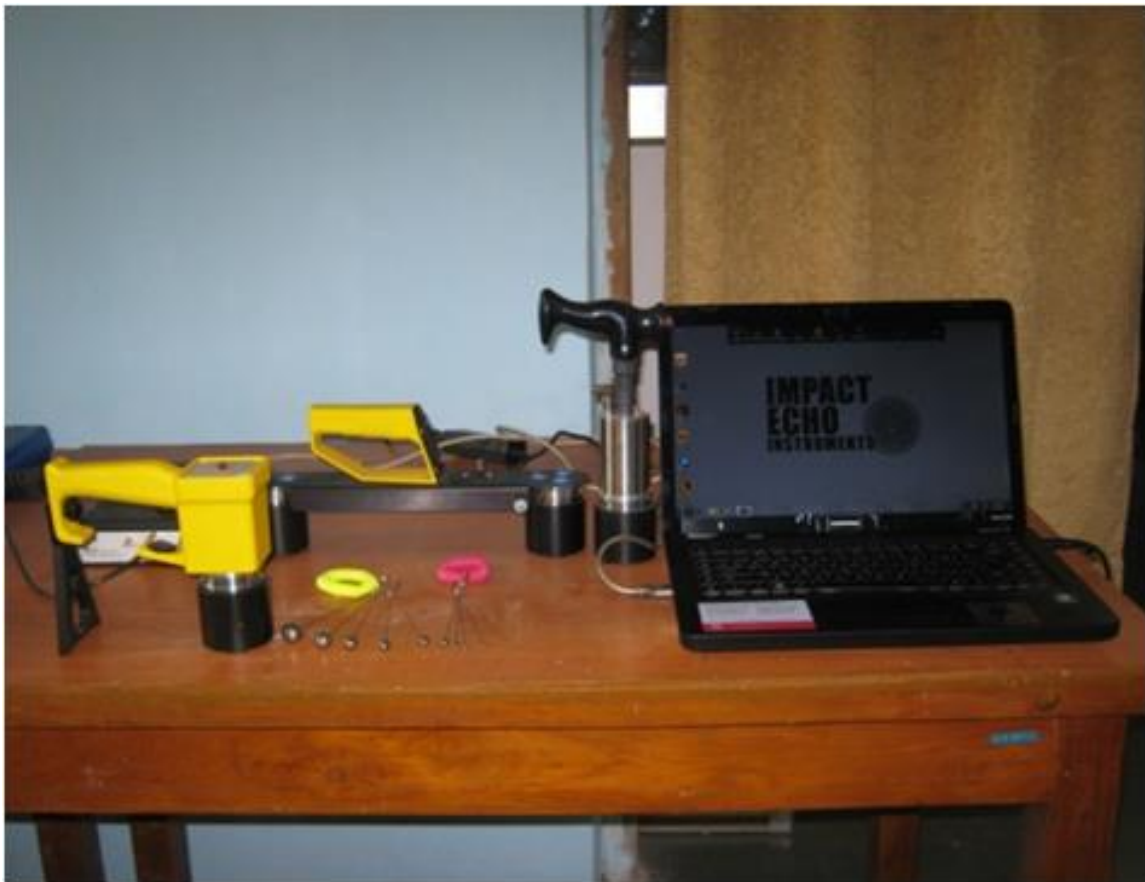
Impact Echo is a method for non-destructive evaluation of concrete and masonry. It is based on the use of impact-generated compression waves that travel through the structure and are reflected by internal flaws and external surfaces. The test is being carried out by following the guidelines mentioned in ASTM C 1383: 98a. Impact Echo method can be used to measure the thickness of slabs, plates, columns and beams, and hollow cylinders. It can also be used to determine the location and extent of flaws such as cracks, delaminations, voids, honeycombing and de-bonding in plain, reinforced and post-tensioned concrete structures. Voids in the sub-grade directly beneath slabs and pavements are easily detected through Impact Echo testing. Photograph of the impact echo test set up is shown in below Fig. Impact Echo testing consists of measuring both the time record and frequency spectrum associated with a mechanical impact on the surface of a structure. As stress waves propagate through the structure, they reflect off internal and external boundaries and cause periodic displacements on the surface.

Impact Echo Test Set Up

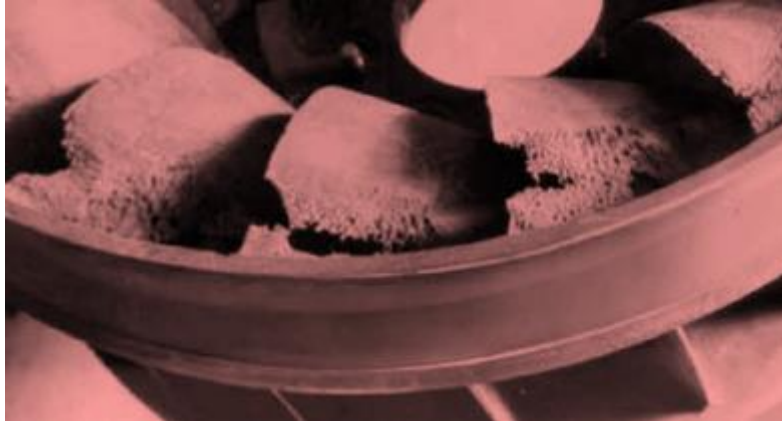
Cavitations are also another major contributor to vibration. This is caused by incorrect flow conditions around the runner or impeller blade profiles and occurs mostly within the higher load ranges. Hydro elastic vibrations occur due to an incorrectly shaped discharge edge of hydraulic profiles (blades, wicket gates, and stay vanes etc.). Self-excited vibration occurs in places where the movement of mechanical parts (seals and clearances, etc.) can influence the flow around or through them.

Turbine Damage by Cavitations

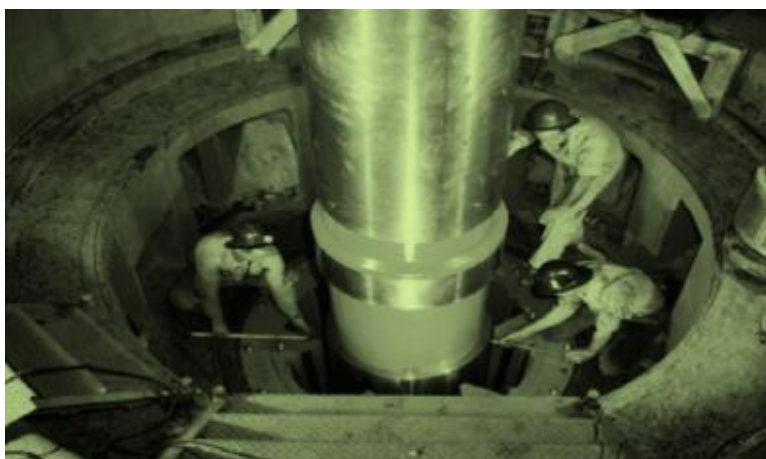
Misalignment in line of shaft also results in vibration; this is in both radial as well as axial direction. These vibrations increase with rotational frequency of lower order harmonics. It also leads to bearing failure and overheating. The shaft misalignment can be either angular or offset. If it is angular, the angle between the machine moved and the shaft centreline of a stationary machine is different in vertical and horizontal planes. This misalignment in shaft may also lead to bearing failure and overheating. Breakage of wicket gate linkage is also due to misalignment. These situations are shown below.

Turbines Misalignment Detection

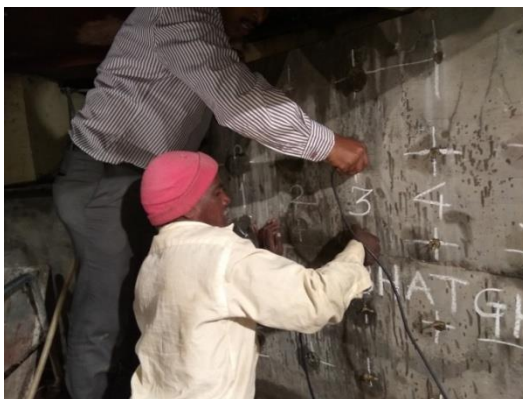
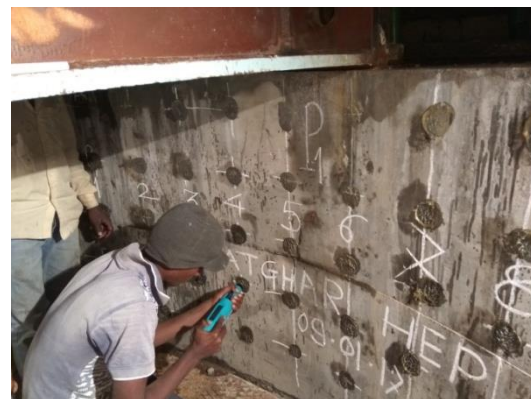
Photograph showing the NDT of pedestal

A Portable Ultrasonic Non-destructive Digital Indicating Tester (PUNDIT) equipment with suitable transducers has been used for this purpose. Elastic compressional wave velocity was estimated at more than 200 grid points covering maximum portion of the concrete of the barrel concrete structure. In-situ quality of concrete was evaluated by comparing the observed rebound number and velocities with adopted velocity criteria and correlating compressional wave velocity with the quality of concrete. The studies have revealed that the in-situ quality of concrete for most part of the barrel concrete structure is of good to very good quality. However, four pedestals may be graded as questionable to poor quality. Based on the studies, remedial measures for repair/ rehabilitation have been suggested of four pedestals. Accordingly, the weak portions were removed by concrete breakers. Four concrete pedestals with M-30 micro concrete were re-casted. The development of concrete strength with time and its in-situ quality was tested by conducting field and laboratory studies.

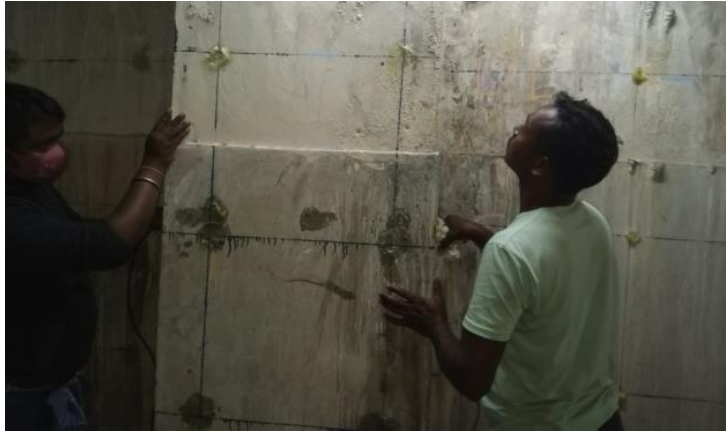
In-situ Ultrasonic tests in progress

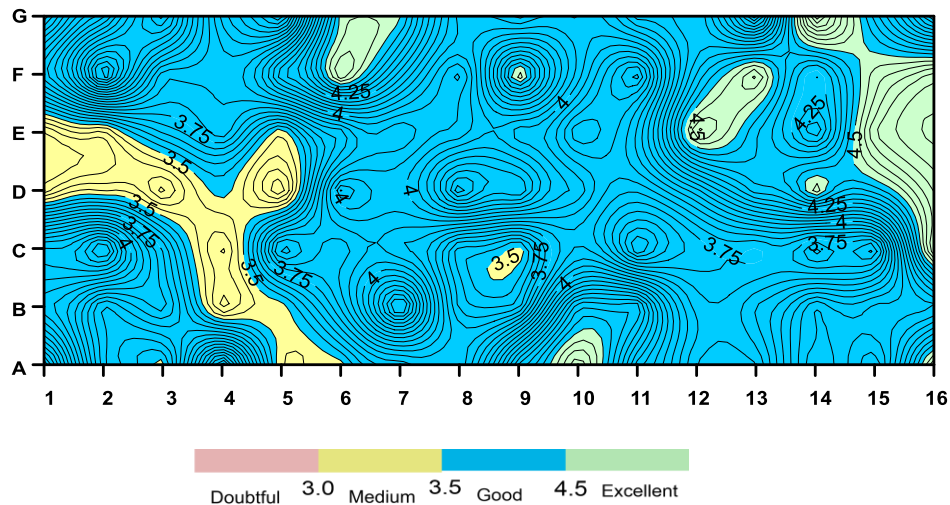
Velocity contours for Conference Room

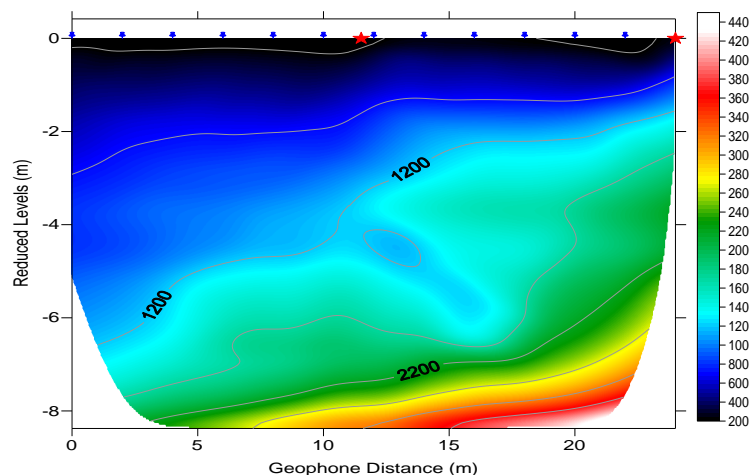
Contour map showing the distribution of velocities with depth

The powerhouse building is located very close i.e. about 1 to 2 m from the vertical rock cliff as shown in above figure. Due to vertical cutting of the rock, frequent rock cliff falling has been observed during rainy season since 2003 putting the powerhouse structure in danger. Considering the importance of the powerhouse structure, it becomes very much essential to ensure the safety of the powerhouse from rock fall. In this connection, based on the request from the project authority, NDT study has been carried out by using different methods such as Ground Penetrating Radar, Seismic Refraction and Sonic wave transmission methods for in-situ quality assessment of the rockmass around the power house. The results of the NDT study identified the weak zones in the rockmass as shown in above contour map and based on the analysis of the results, necessary remedial measure were suggested for strengthening of the rockmass around the power house by grouting. It was recommended to carry out cementitious grouting at all the locations in order to improve the strength of the rockmass. Accordingly, cementitious grouting using grout mix design, has been carried out at site by following the suggestions made by CWPRS. Further in order to assess the efficacy of the grouting at site, GPR study has been carried out at one location. GPR study results revealed that grouting materials have travelled into the voids located in the rockmass and which in turn significantly improved the quality of the rock mass after grouting. Hence, it is suggested to continue with the same procedure of grouting at other locations at the site to further improve the quality and strength of rockmass at other distressed locations.

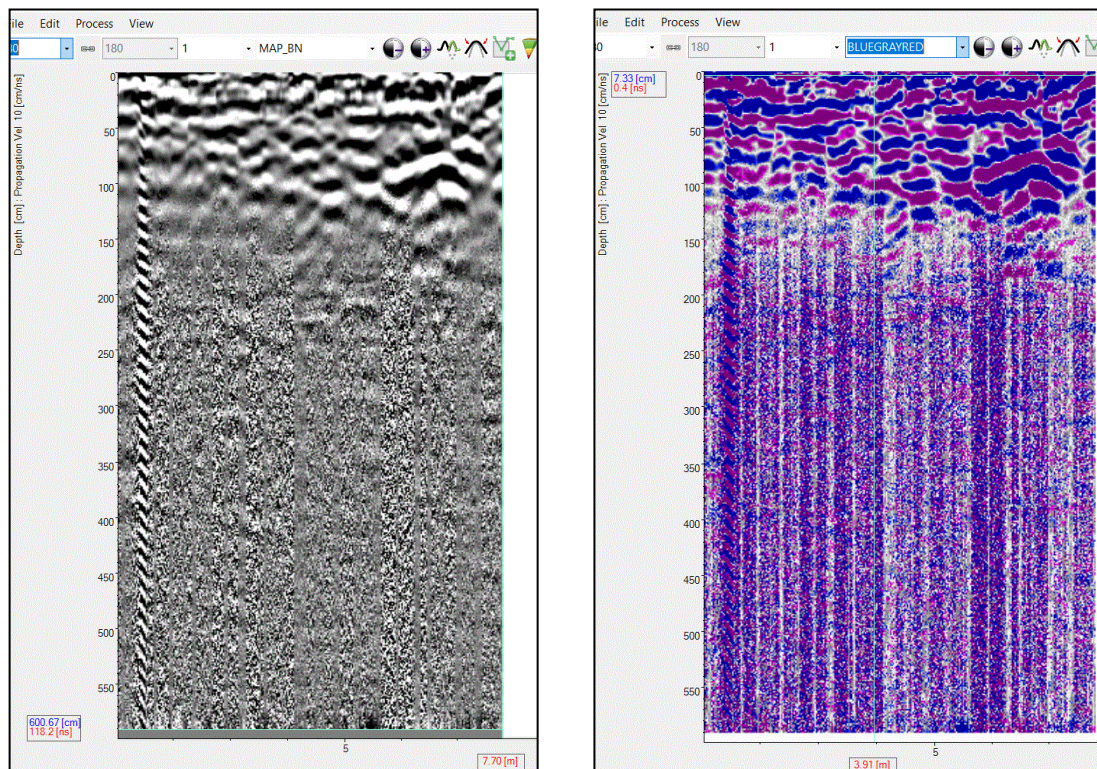
GPR Image Obtained at about 3 m from the Rock Face

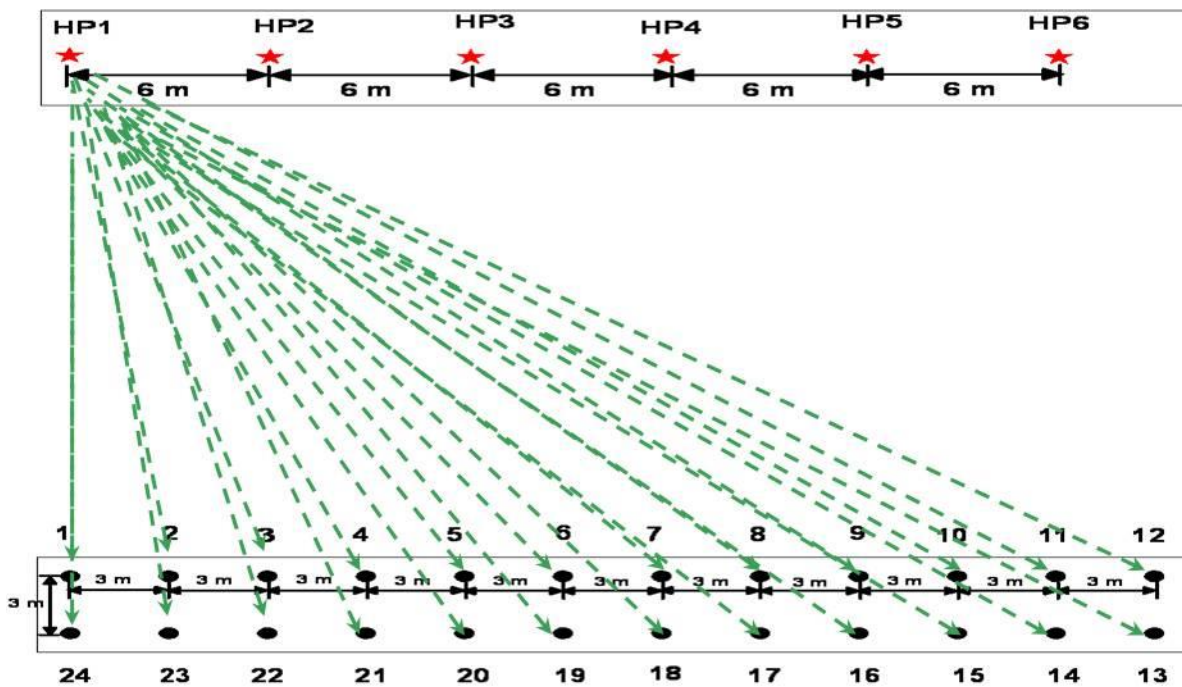
Pattern B (12 points x 2 lines): To cover selected portion 24 geophones were fixed in a linear type pattern on downstream side. The Locations of geophones were marked as 1 to 24. Pattern B is used for testing of all masonry dams.

Marking of Geophones and Location of Hammer Points in Pattern B

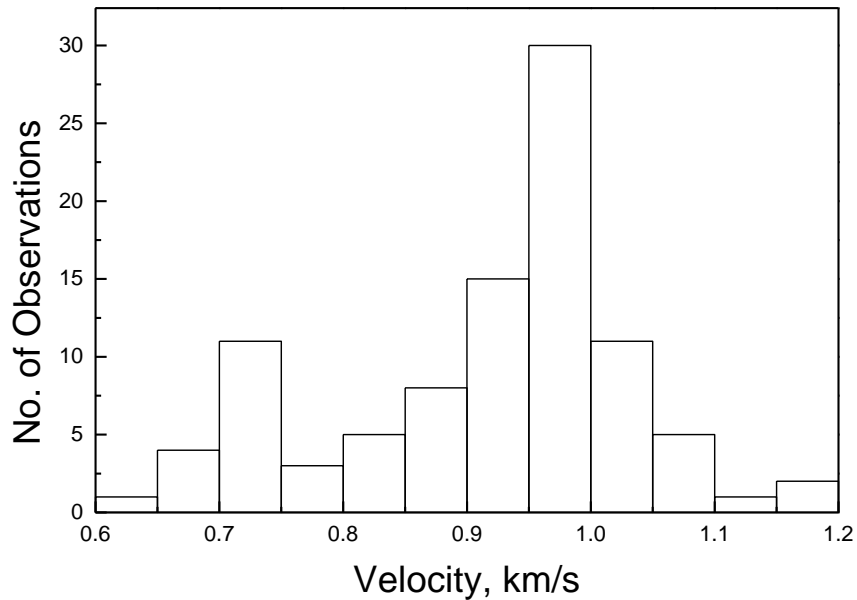
From the results, it has been observed that the velocities of elastic compressional waves in the earthen dams of Vihar dam No. 1, 2, 3 are in the range of 0.2 to 2 km/s which indicates the quality to be of good to very good type material.

Distribution of P-wave Velocities Observed at Vihar dam No. 1&2

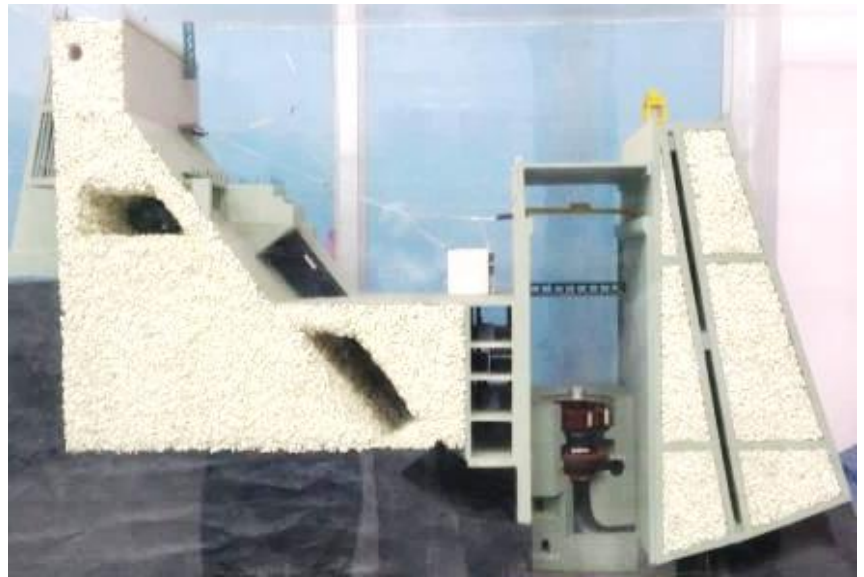
Cross sectional model of Kadana Dam Power House (Photo courtesy: Kadana Dam Authority)

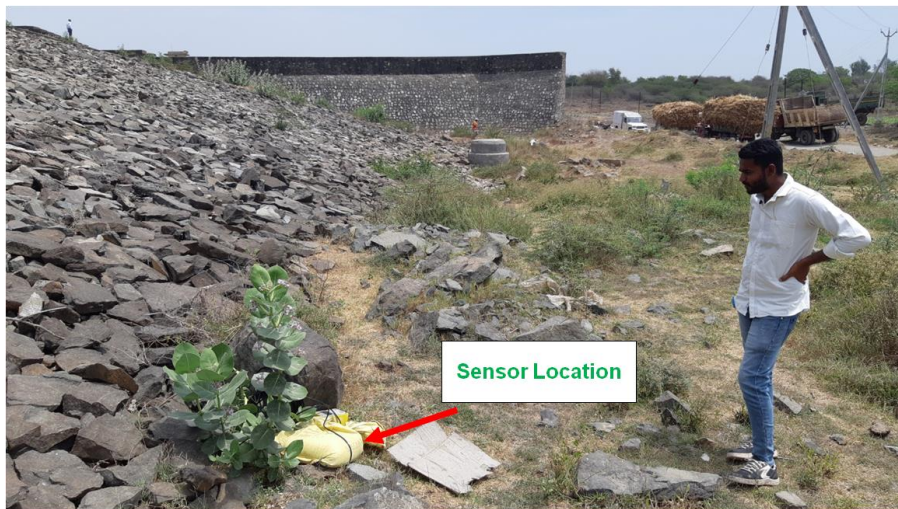
Vibration Levels Observed at Base of the Embankment

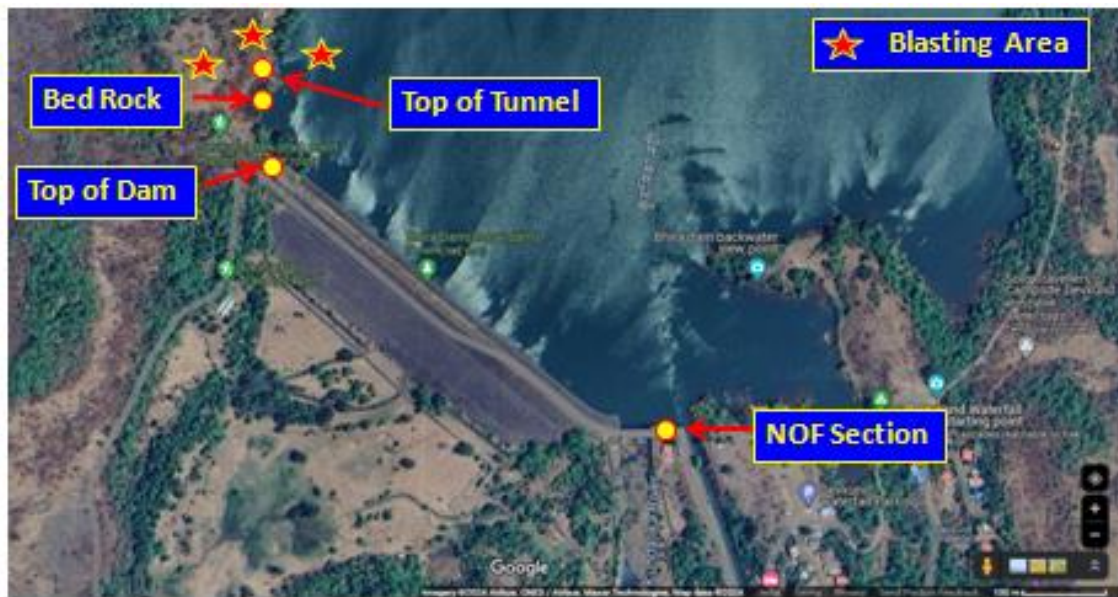
Map showing the monitoring and excavation locations
(Courtesy: Google LLC)
